Failure of San-men Gorge Reservoir Project, China

December 1967

FAILURE OF SAN-MEN GORGE RESERVOIR PROJECT, CHINA

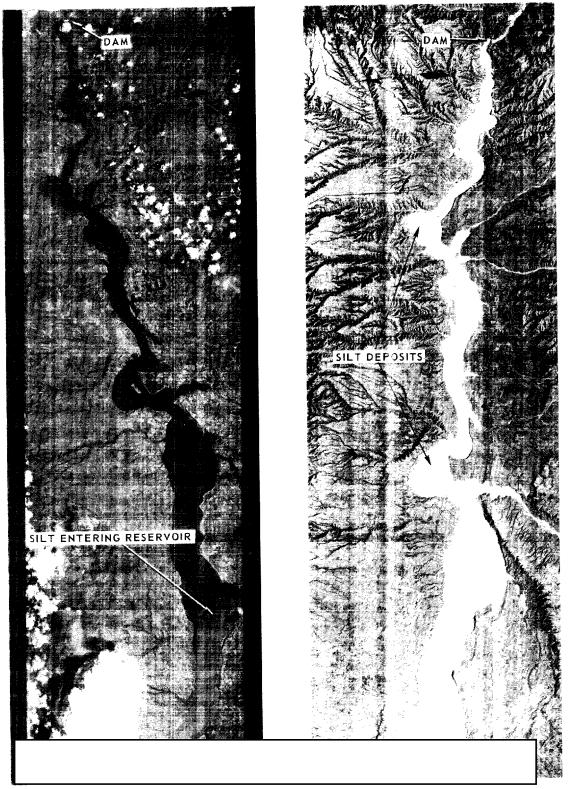
FIGURE 2. SAN-MEN GORGE RESERVOIR

The San-men Gorge Reservoir is situated in a keep canyon on the middle reaches of the Yellow River (Figure 2a). When filled, the reservoir extends 55 nautical miles (nm) upstream from the dam at San-men Gorge to the confluence of the Yellow and Wei Rivers. The reservoir dam is reported to be 350 feet high and is approximately 3,000 feet long. Its capacity is reported to be over 28 million acre feet.

Photography Photography Photography	revealed that the reservoir
was partially filled. The tone of the water of	entering the reservoir indicated
that it was carrying a large amount of silt (Figure 2a), and the volume of
water in the river downstream from the dam app	beare i to have been reduced.
	sluite gates were open, the
ceservoir was empty, and large deposits of sil	it were visible in the reservoir
(Figures 2b and 3). Later photography	
revealed that all of the sluice gat	tes continued to be left open,
and the reservoir was still empty.

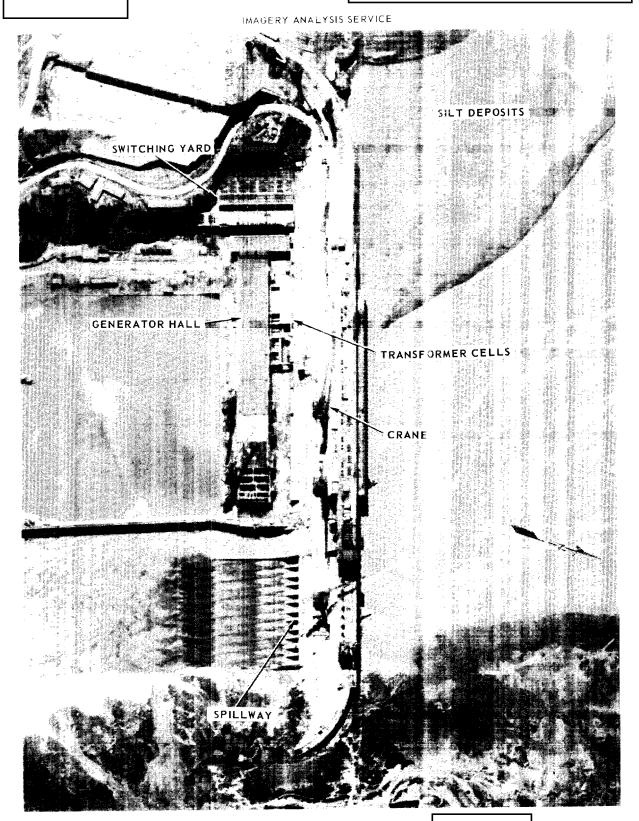
FIGURE 4. SAN-MEN HYDROELECTRIC DAM

The external features of the hydroelectric power plant associated with
the dam at San-men appeared to be in the late stages of construction on
photography (Figure 4). At this time all of the cofferdams
and the construction equipment that had been located on the raver floor were
removed. The switching facility, substation, and transmission lines were
mearing completion and the last of eight turbogene ator sections was being
roofed; however, it was not possible to determine the number of turbines
or generators that had been installed. Covered transformer cells (two ber
turbogenerator) were being constructed between the generator hall and dam;
six of the cells were under construction. More resent photo coverage of
indicated that the power house was completely
roofed, and that only three of the transformer cells had been covered. The
switching facility at the western end of the generator hall appeared to be

completed with eight sets of switch gear installed. A cantilever crane was
still located on the roof of the power house, and straveling support tower
with aerial cable-way was still present. Onphotography three
still located on the roof of the power house, and straveling support tower with aerial cable-way was still present. On photography three burbine housing outlets were discharging water; on photography
still located on the roof of the power house, and straveling support tower with aerial cable-way was still present. On photography three turbine housing outlets were discharging water; on photography four outlets were discharging. The spillway has been in operation on all
still located on the roof of the power house, and straveling support tower with aerial cable-way was still present. On photography three turbine housing outlets were discharging water; on photography four outlets were discharging. The spillway has been in operation on all photographic coverage. Since no head of water has formed and

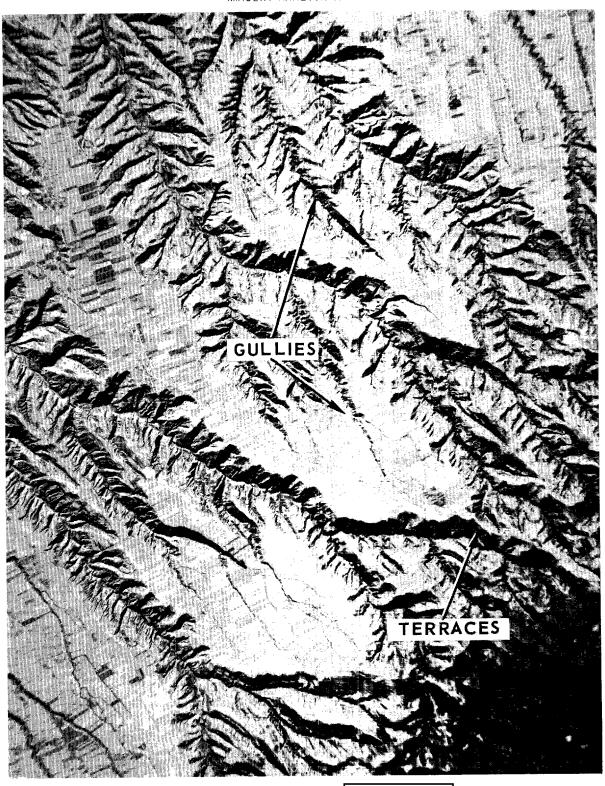
FIGURE 5. ERODED LOESS,

The Loess Plateau is an old dissected peneplain which has been covered by a layer of wind deposited dust varying from a few feet to over 250 feet thick. This light unconsolidated loess is commonly overtilled, and without its natural vegetation cover and under the influence of heavy summer downpours, is extremely susceptible to erosion. Photography reveals (Figure 5) that natural vegetation covers less than five percent of the plateau, and that gully and sheet erosion occur over a large portion of the drainage area. With 65 percent of the total annual rainfall occurring in July, August, and September (Table 1), usually as heavy downpours, tremendous quantities of silt are being washed into the Yellow River.

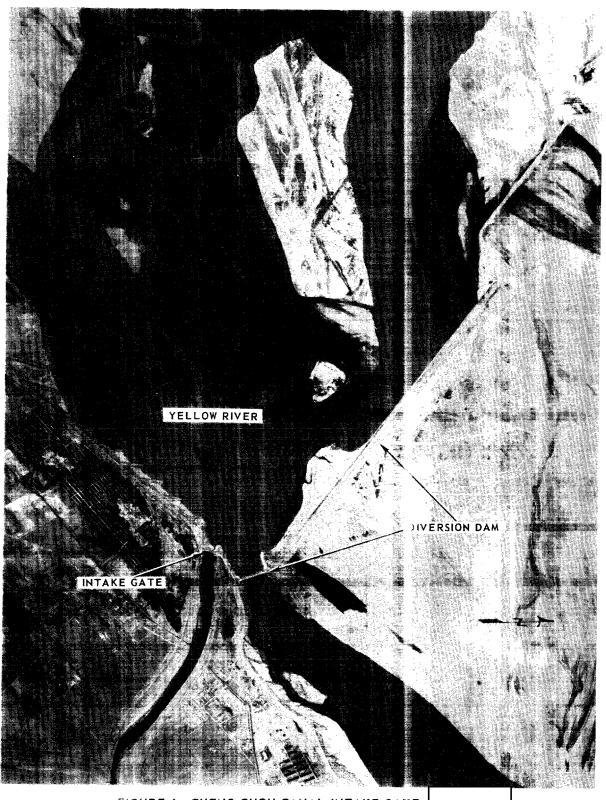
FIGURE 6. CHENG-CHOU CANAL INTAKE GAME,

indicated the Photography Chinese are having difficulty in obtaining a sufficient supply of water for the Cheng-chou and Lan-feng Irrigation Projects (Figures 6 and 8) located 130 and 210 nautical miles downstream from the dam. During this five year period the canal intake gates were photographed in both the wet and dry seasons, times when the river would normally be at its highest and lowest Levels. Dates when the water was above or below the intake gates are given in Table 2. This table includes all available coverage from the date the Since there is ins fficient photographic dam was closed until coverage of the canal intake gates before the dam was closed, the extent of retrogression cannot be determined. It is evident, however, that only a small amount of water for irrigation is available during the wet season and that even less water is available during the winter wheat growing season of March, April, and May when evaporation generally exceeds reinfall in these irrigation projects. In addition, during the wet season of 1905, flood waters destroyed the major portion of the Cheng-chou Diversionary Dam located at 34-55N 113-36E (Figures 6 and 7). This further complicates the task of obtaining sufficient water for the Cheng-chou Irrigation project.
